“Alligator-back” – Causes and Correction

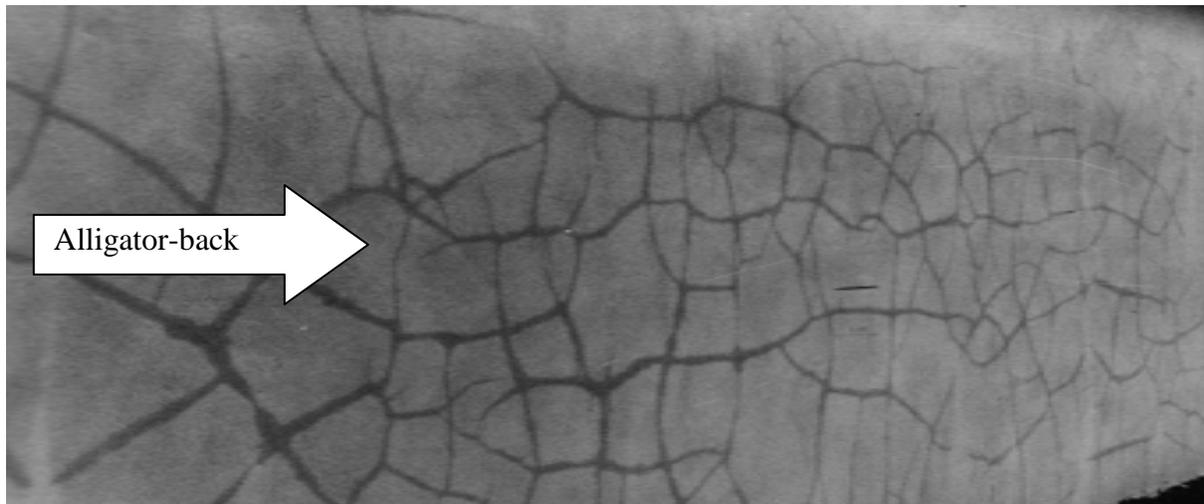
The crack pattern in the photo below is due to the reduction of volume due to rapid loss of water in the fresh plaster. This is a common and natural consequence. Most of this type of cracking is preventable by keeping the wall damp for several days after plastering.

Several factors may contribute to this loss. When fresh plaster is direct-applied to a solid substrate (concrete, block, stone, brick) the substrate should be dampened to prevent the type of cracks shown above.

Concrete block come out of the plant in a still wet state. This volume of water makes the block as big as it will ever be. As soon as it is set in the yard it begins to shrink as it dries out. Then, when it is semi-dry it gets to the jobsite and is placed in the wall where it dries further. So, when wet plaster is placed on dry block, the block will absorb the moisture out of the plaster in an effort to satisfy its' and the mortar joints' thirst for water. This reduces the volume of the plaster too rapidly for the plaster to retain its' original volume, thereby, causing a small shrinkage crack to appear.

These cracks are cosmetic in nature and, in most cases; do not penetrate the entire plaster thickness, just the finish coat. They therefore rarely pose any threat to the durability or water tightness of the plaster assembly.

Prevention can be as simple as dampening the wall prior to application of the plaster and fogging the wall several times per day for three to four days after application. Weather conditions can vary this requirement.

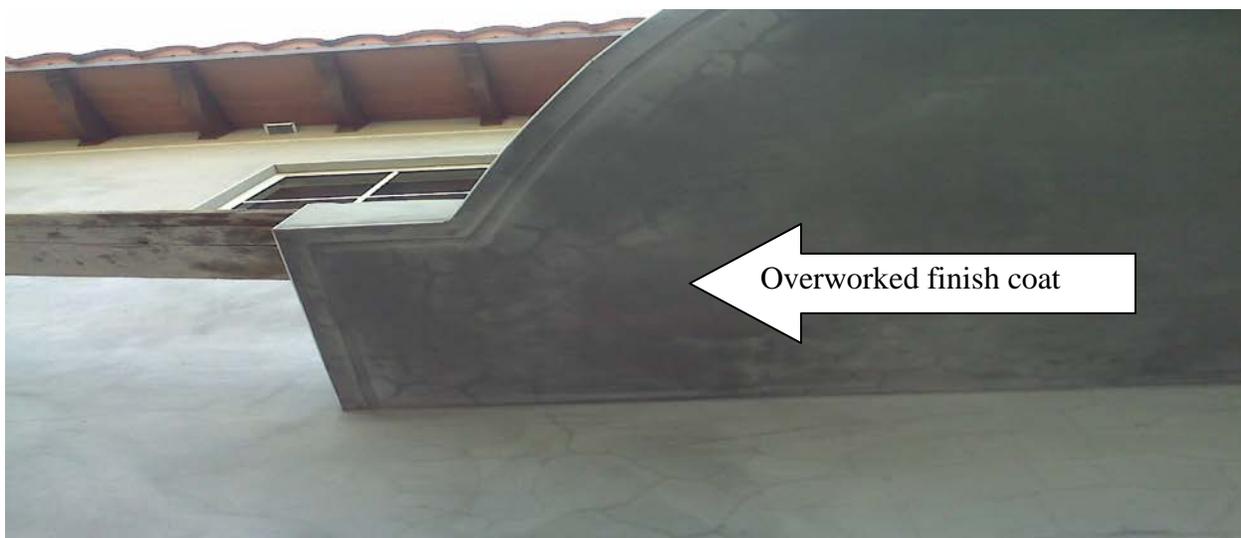
The photo below shows a similar issue on the underside of the overhead structure but with an added factor. It appears much the same as the cracking above but with much smaller “alligator-back” patterns. This condition is usually caused by overworking the plaster but can also be the result of too fine a sand. This happens when an area begins to reach initial set before the plasterer has had time to get it floated. Overworking causes the finest particles of sand to come to the surface producing a layer of plaster with all the same size aggregate. Plaster aggregate is necessarily of varying sizes to promote mechanical bonding within the plaster itself. This is very similar to overworking concrete.

It may be unwise to try to seal all of these cracks and it is generally considered inadvisable where cosmetics are the only reason for doing so. These minor cracks are usually more pronounced after a rain or on a foggy morning as the wall begins to dry out. Often, the repair of this type of crack is more visible than the crack itself. The owner should decide which direction to go.
