“Ghosting” in Stucco

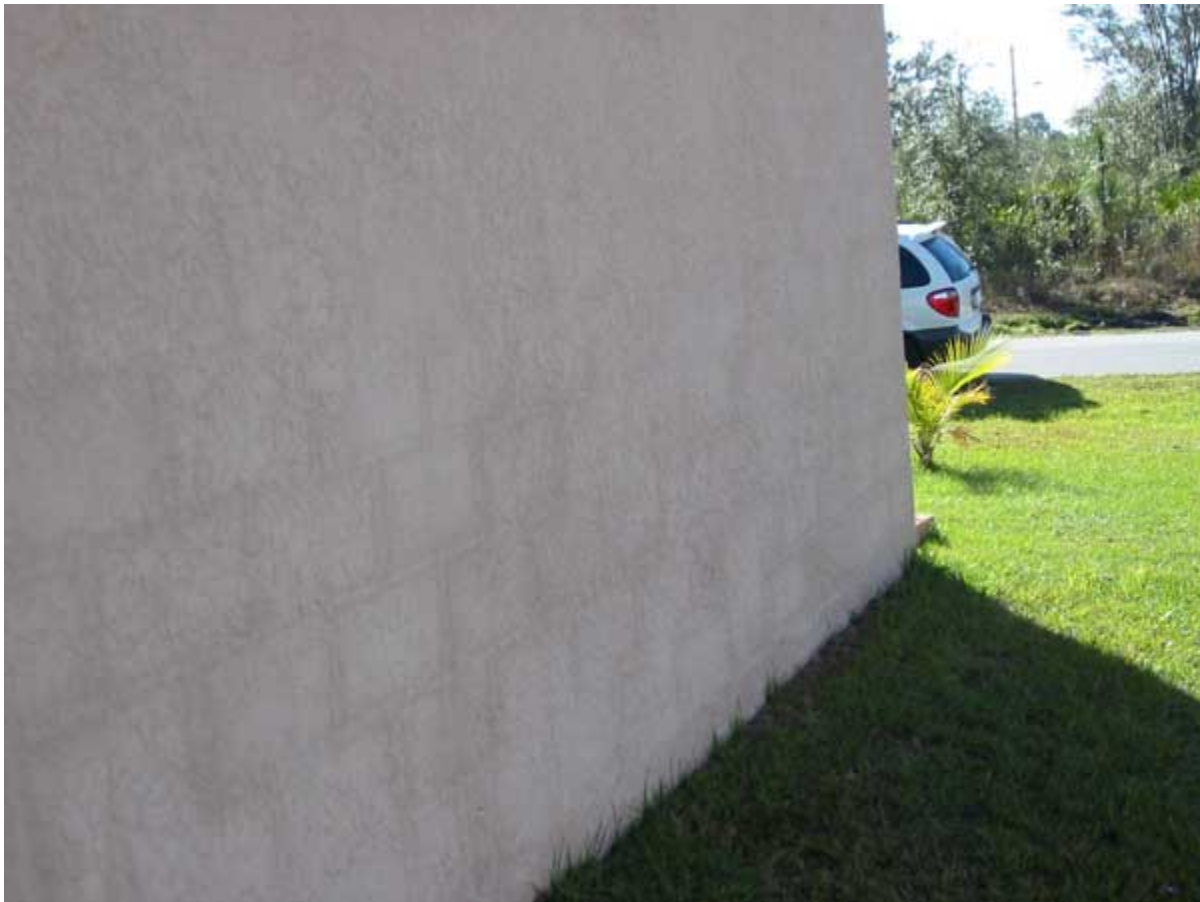
The term “ghosting” in stucco refers to the visibility of the mortar joints in the concrete masonry wall substrate. Where stucco has been properly placed and cured, this should not be evident. Ghosting is caused by several factors but is preventable with care and precautions.

Factors affecting the ghosting phenomena include curing of the masonry wall, curing of the stucco and thickness of the plaster.

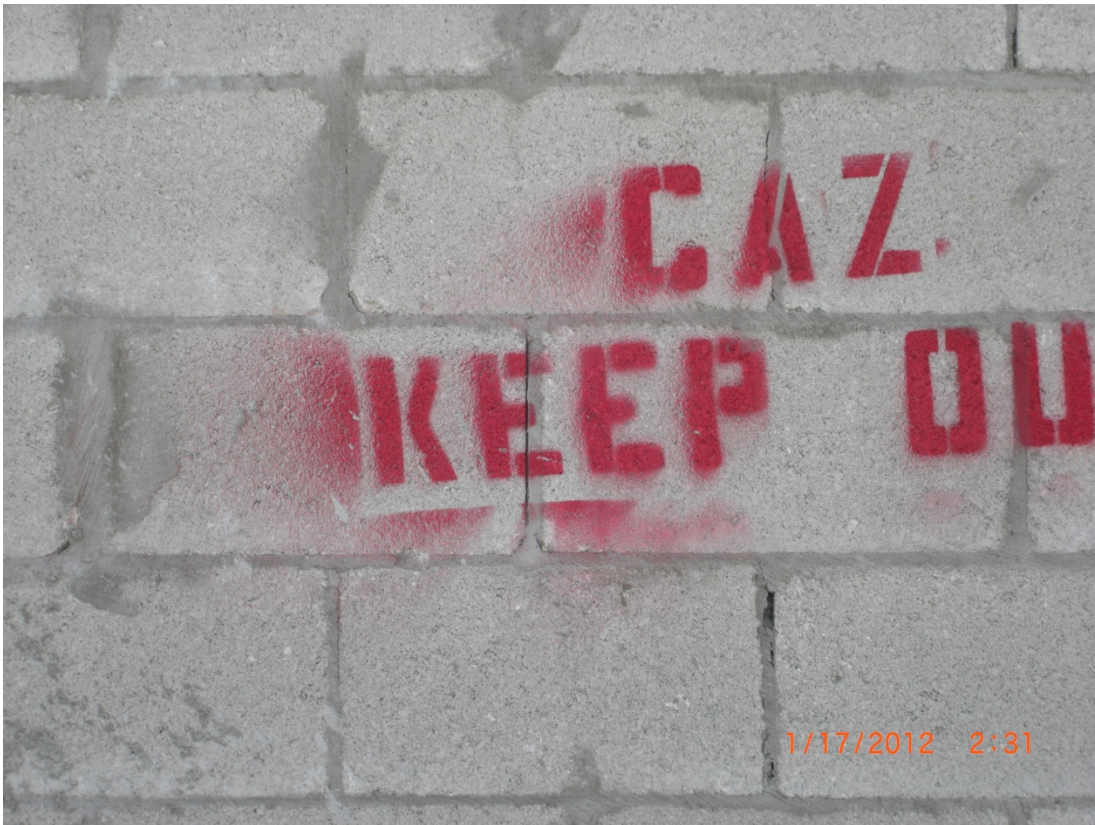
The crack above is due to mortar shrinkage. Sometimes these cracks will continue in a “stair step pattern following the mortar joint. Shrinkage cracks are very narrow (usually less than 1/32 inch) but will reflect through the stucco.

On site, the block are set with fresh masonry mortar. By necessity and design, the block absorb the moisture from the wet mortar which carries with it the cement paste that will hydrate (cure) and create the bond that both holds the block together and apart. This process actually creates the initial cause of future ghosting. The mortar dries out faster and is less dense than the block itself. This causes it to both shrink somewhat and to be of a slightly different color. Remember that the block got to stay moist for 24 hours while the mortar does not.
